FEBRUARY 2021 | CASE STUDY

We Energies Deploys Remote Monitoring to Keep an Eye on Transformer Bushings

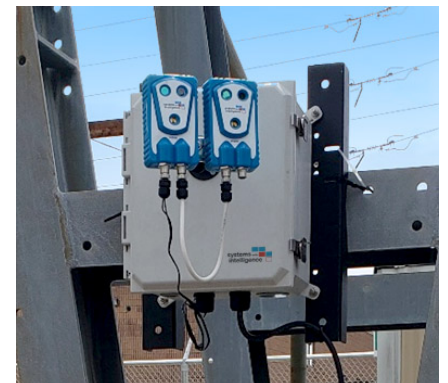
Figure 1 – IM500 thermal plus visual sensor module can be installed close to high power.

The IM500 is a programmable IoT module that scans key points on critical assets and doesn't require an outage to install it. The IM500 includes a thermal sensor and adds an additional visual sensor to provide the user a dual view of the asset. With built in cellular connectivity and low power requirements, the IM500 is easy to install and is up and running in minutes. It has a solar power option and connects automatically to the Systems With Intelligence cloud that stores and processes the collected temperature data. The IM500 has thermal analytics designed for electric power applications allowing comparative measurements on 3-phase systems and automated alarms to notify operators when temperatures exceed the defined limits.

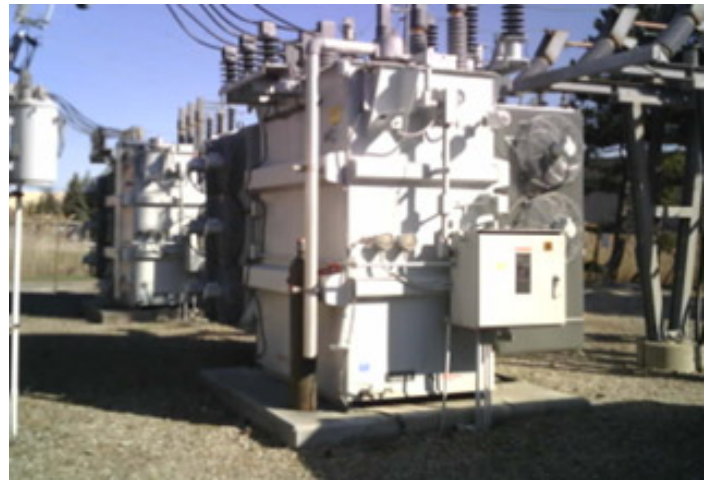
Figure 2 - Visual image of the transformer recorded with the IM500 daily snapshot.
